Inspection – Ascertain
Condition & Valuation

SURVEY REPORT NO. 11-2019-0481

M/V "BOB ROUSE"

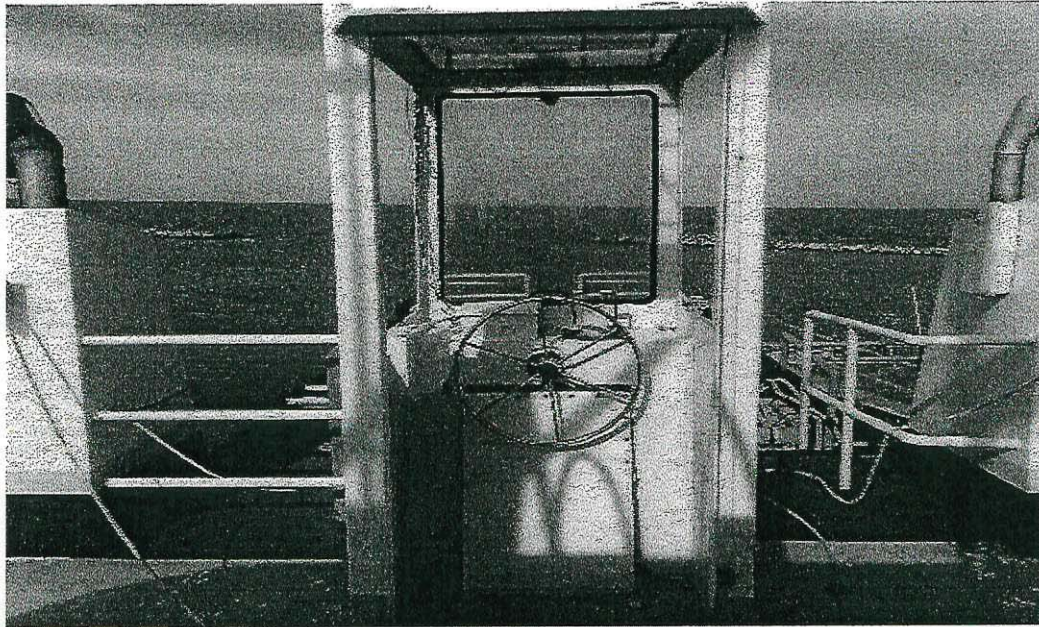
**VIEW OF STERN OPERATOR'S STATION & CONTROLS ONBOARD THE
"BOB ROUSE"**

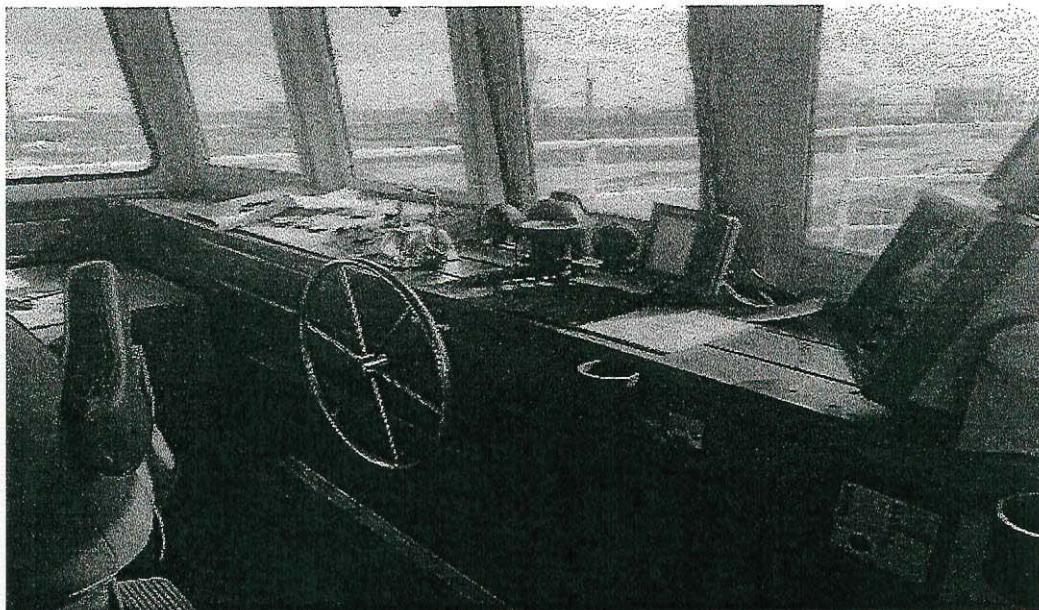
- pilothouse contains the following equipment:
 - two (2) standard VHF radios.
 - one (1) SSB/Encoder/Decoder.
 - three (3) *Furuno* GPS.
 - one (1) *Furuno* radar.
 - one (1) engine display monitor.
 - one (1) *Richie* compass.
 - one (1) captain's chair.
 - one (1) bench seat.
 - one (1) chart table.
 - one (1) *Lasko* fan.
 - one (1) general alarm panel.
 - one (1) two (2) drawer file cabinet.
- located atop the pilothouse is a mast pole with navigation lights, running lights, a double air horn, searchlights, a radar scanner. All appear in fair condition; However, multiple antennas were missing.

**VIEW OF THE FORWARD PILOT HOUSE OPERATOR'S STATION
& ELECTRONICS ONBOARD THE "BOB ROUSE"**

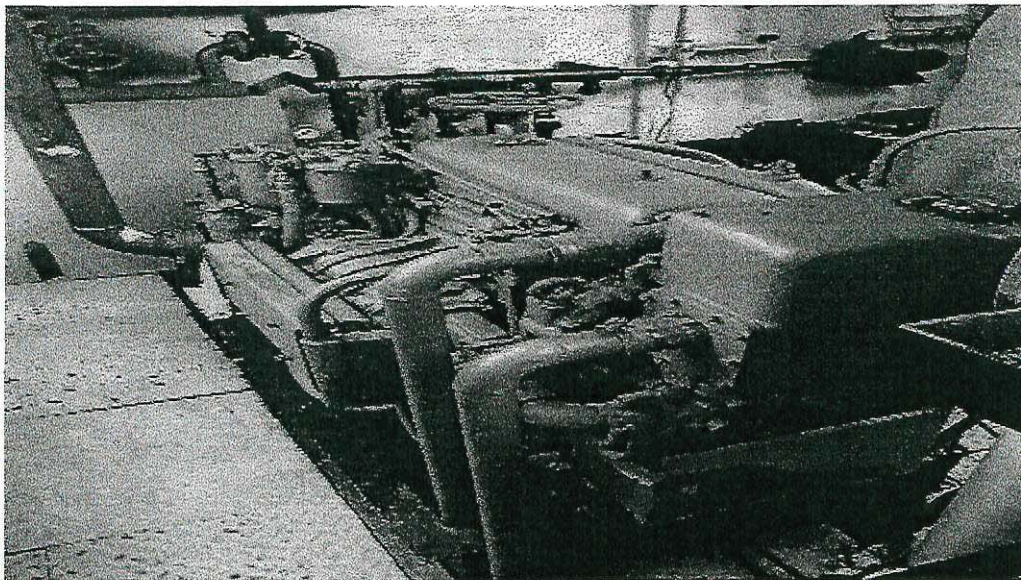
- exterior of the hull appears to be in good condition with a black coating.
- vessel interior is in good condition.
- side shell plating and bulwarks are in good condition.
- deckhouse is in good condition.
- port generator was sighted in operation and appears to be in good condition.
- starboard generator was not operated at the time of survey.
- electronics were not operated at the time of survey.
- propellers, tail shafts, and all other underwater gear were not operated during this survey and are in an unknown condition.
- bilges contain normal amounts of water.

**VIEW OF THE STARBOARD GENERATOR ON BOARD
THE "BOB ROUSE"**

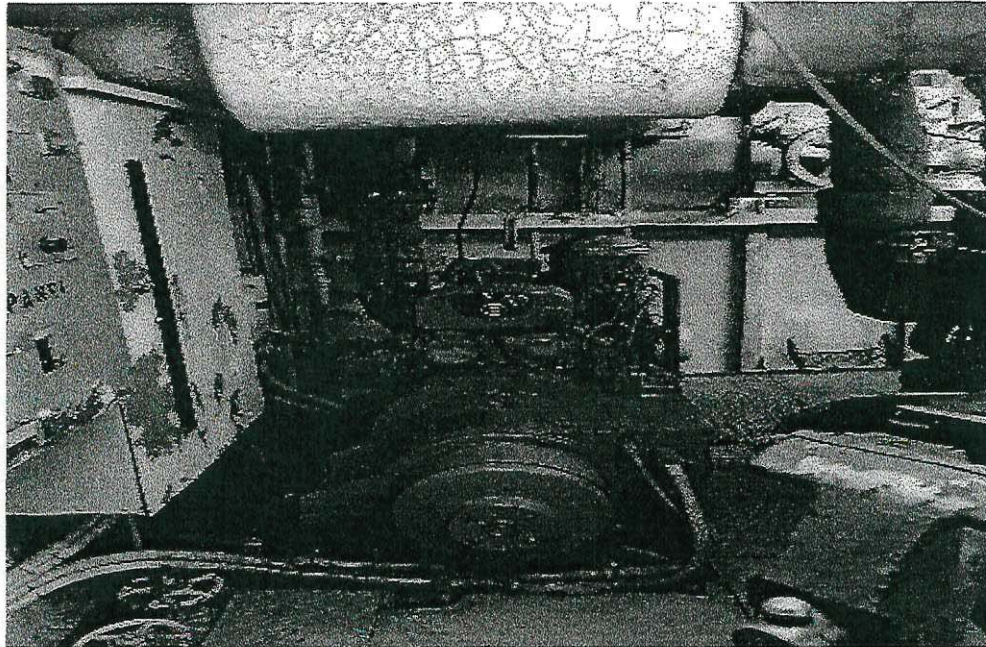
**VIEW OF THE STARBOARD GENERATOR ONBOARD THE
"BOB ROUSE"**

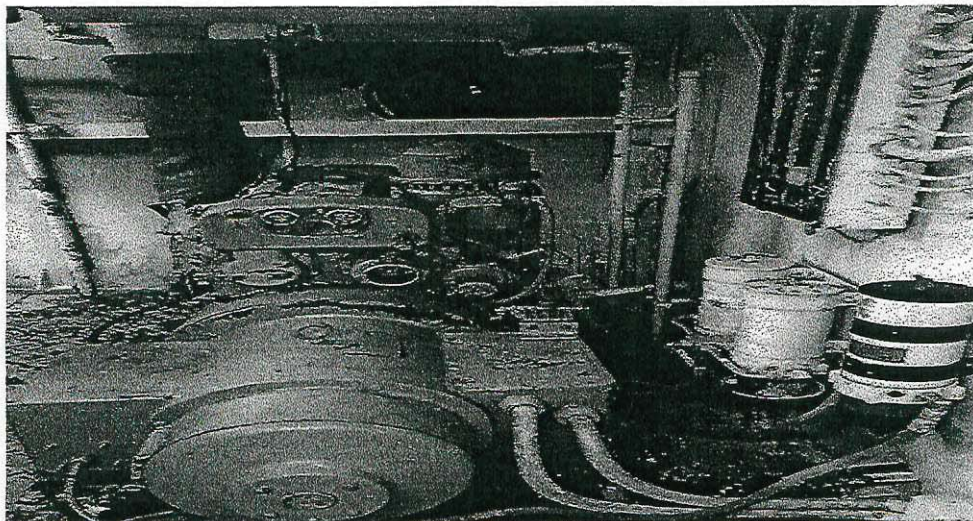
**VIEW OF THE PORT GENERATOR ON BOARD
THE "BOB ROUSE"**

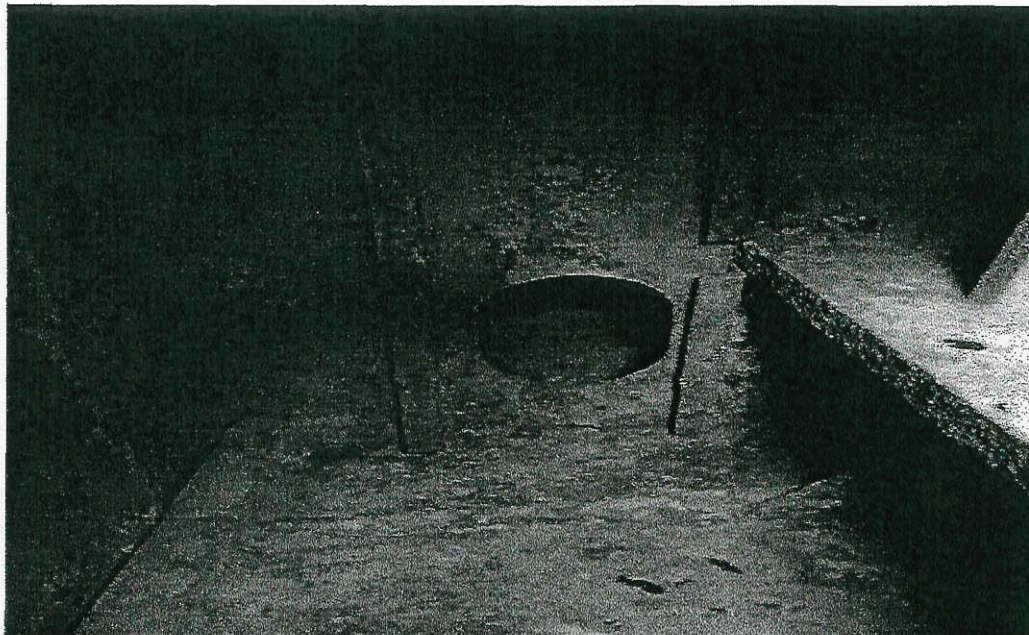
- compartment contains 0 of water.
- water salinity is 0 ppt.
- compartment contains traces silt/mud.

**VIEW OF INTERNAL STARBOARD STERN COMPARTMENT LOOKING
FORWARD ONBOARD THE "BOB ROUSE"**
